This week's update looks at **WORK TRAVEL** and highlights two issues that have cropped up in recent incident reports from contractors.

Work Travel – 2nd vehicle loses a wheel

Work Travel - Worker drowned accessing Work Site

“CONTINUOUS LEARNING - OUR SAFETY JOURNEY”

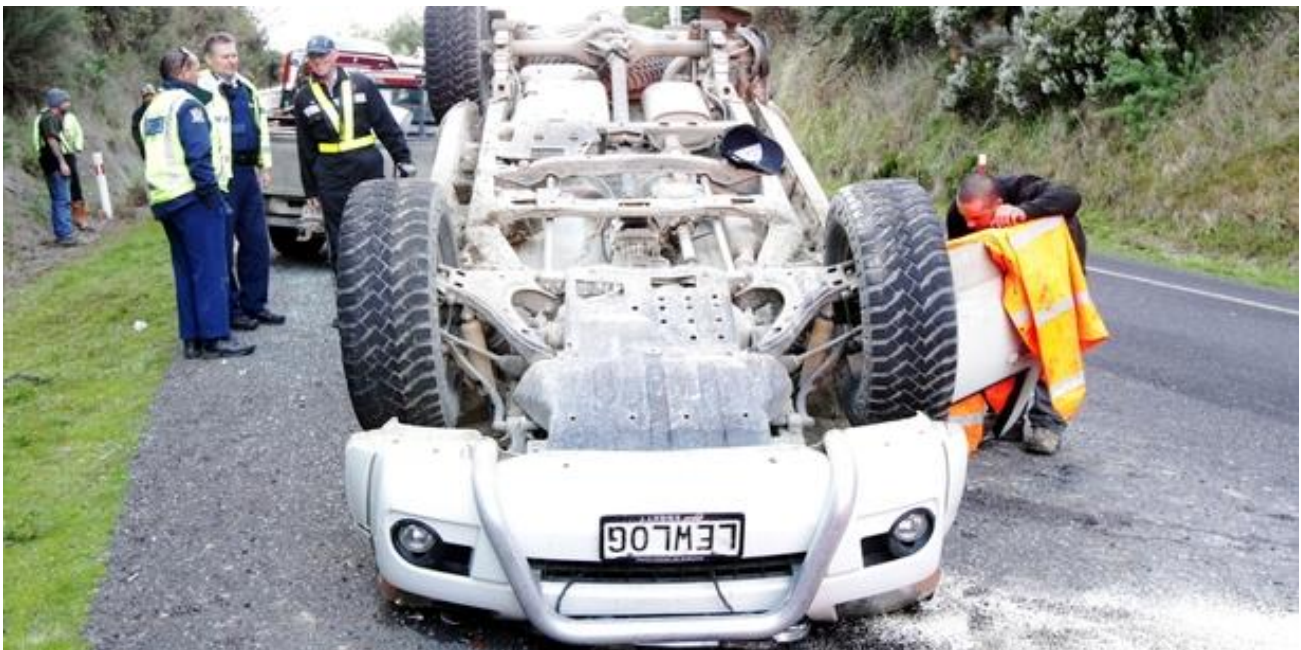
On 20 May a Taupo based forestry contractor was travelling home from work when his vehicle lost a rear wheel resulting in a rollover on the Napier-Taupo Road (photo below). The driver was knocked around and admitted to hospital but is now on the mend.

The reality is that a wheel is subject to a number of forces which act to loosen the wheel nuts. If one of the wheel nuts loosens then these forces are distributed over the remaining nuts, which can cause the adjacent nuts to loosen as well. As more nuts become loose the process accelerates as the overall clamping force holding the wheel in place decreases. When the clamping force reduces sufficiently the wheel will move on the hub. This results in side loading and further loosens the remaining nuts, which, if not

spotted in time, leads to elongated stud holes, fatigue failure of studs, fretting cracks and in many cases wheel loss.

The use of impact tools is a common cause of both under-torquing and over-torquing because the actual torque (and therefore clamping force) applied depends on a wide range of factors. A common approach to the problem of wheel insecurity is to deliberately over torque. This normally results in stud failure.

- Periodically inspect wheels during pre-trip walk around inspections for signs of damage, cracked or distorted wheel rims, broken or loose fixings, and signs of wheel or wheel nut looseness (bright metal or rust marks around the nuts or captive washer seating).
- Ensure that after a wheel has been fitted the wheel nuts are rechecked for correct torque after a short period of in-service running. Between 50 to 100 kms is commonly recommended (do not slacken and re-tighten). Maintenance procedures must include a flag to ensure this has occurred.
- Ensure that wheel nuts are checked for security and tightened to the **recommended torque** (manufacturer's spec) with a calibrated torque wrench at routine maintenance intervals.
- Establish causes of wear and damage on loose nuts before re-tightening.
- Ensure that manufacturer's written instructions are followed.

If you have aluminium rims be extra vigilant as nuts tightened against a flat aluminium rim surface are thought to be prone to loosening.

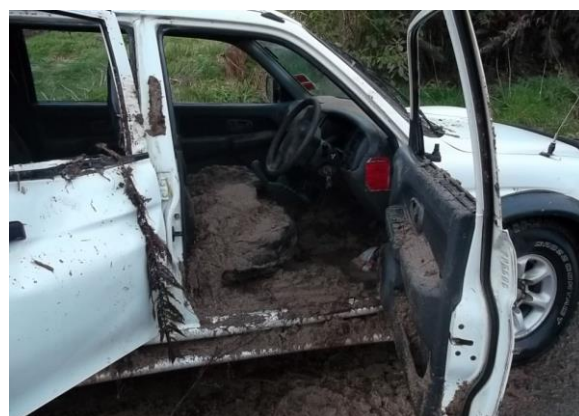
On one occasion they had a go, floated away and had to abandon the vehicle.

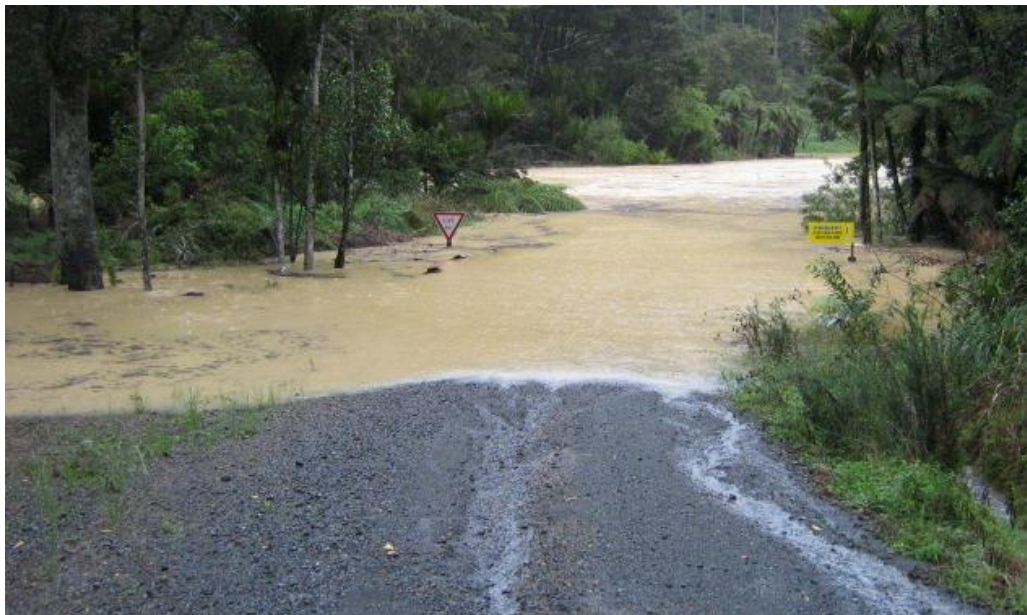
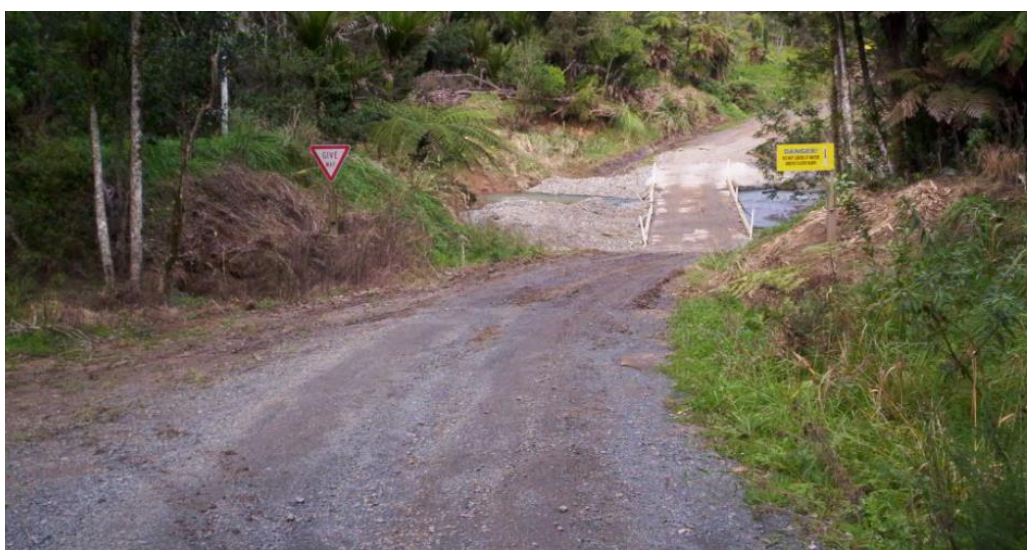
The photos below show how things can change quickly after intense rainfall in forestry catchments. If you have to cross a flooded ford you must be 100% sure it can be crossed safely. If in doubt go to PLAN B (B for Better).

Rayonier Engineers / Harvest Planners – Take the time to periodically assess river crossings in your patch. Ensure that approaches are sound and that depth markers and warning signage is in place. Good idea to inspect following flood events to ensure the risk reduction measures (markers / signs) are still in place.
