SAFETY ALERT

Breaker-Out Injured While Securing Skyline to Backline Anchor Stump

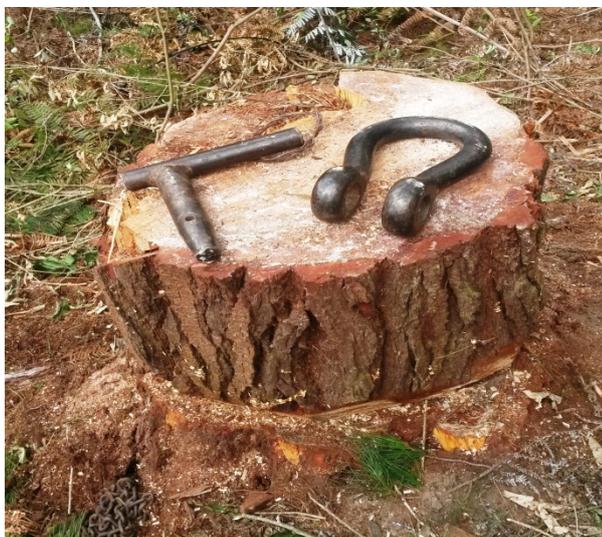
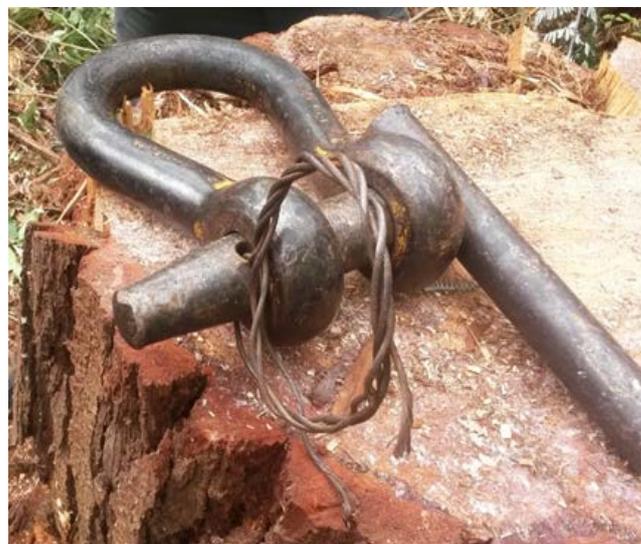
As the skyline moved into the new corridor it freed from two stumps it was caught on causing it to become shock-loaded 2-3 times. During this shock-loading and without warning, the shackle pin released from the skyline shackle causing the skyline to unwrap at speed from around the stump.

The eye of the skyline struck the breaker out positioned beside the stump with force on the right leg slightly below the knee resulting in a fracture of the lower knee and chipped knee cap.

The Knock-Out Pin Shackle used to secure the Madill 171 skyline to the anchor stump

1. ***Screw in shackles are the preferred option when attaching a skyline to a back anchor stump.***
2. ***If a 'knock out shackle' must be used it is imperative that the molly grommet is suitably sized, correctly fitted and inspected following each new skyline shift, add checks into hauler operator's diary, date and time checked.***
3. ***No person should stand closer than 3 metres to an anchor stump during line tensioning. They must also not be standing directly behind the anchor stump.***
