## Dismantled A-frame slides and kills worker

### INCIDENT

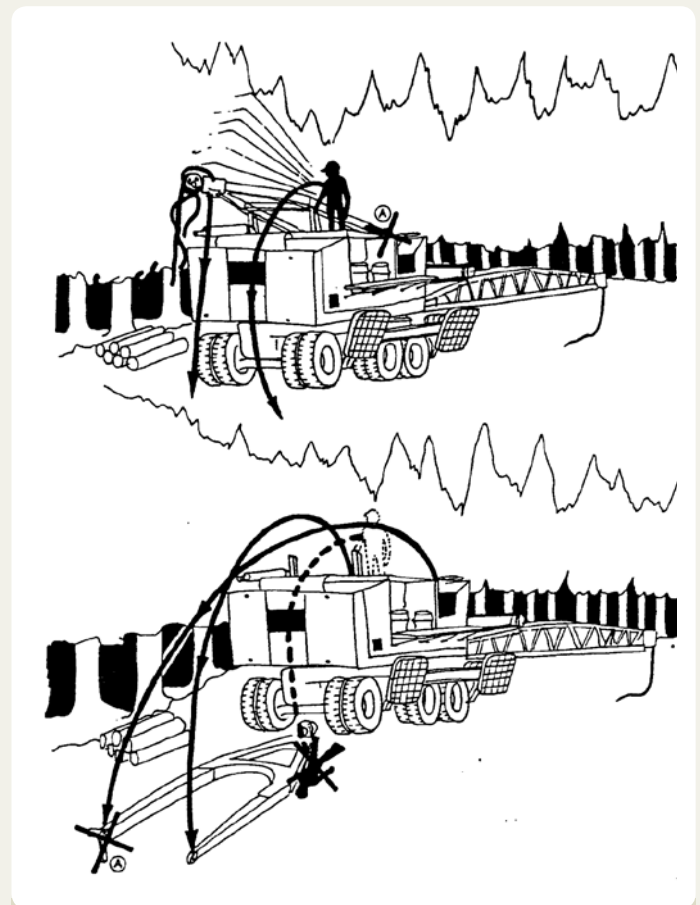
The A-frame tower had been lowered and one pin removed from the foot of the frame. Another pin that held the footplate of the A-frame tower could not be removed. It was decided to remove the studs holding the other foot plate to the hauler.

When the last stud was removed, the A-frame tower slid backwards off the machine supports. The worker either jumped or was knocked off the hauler. He was seen standing at the rear of the hauler when the head of the A-frame dug into the ground. The A-frame tower then pivoted, toppled over and struck the worker.

The investigation determined that the A-frame should have been secured when de-rigging was carried out.

De-rigging is not to be carried out without assistance and back-up being available.

To provide more balanced weight distribution, either a further support should be placed at the rear of the hauler or the support system should be redesigned.
